Common Structural Details and Deficiencies in Indonesian RC Buildings: Preliminary Report on Field Investigation in Padang City, West Sumatra

Syafri Wardi^{#+}, Yasushi Sanada[#], Michihiro Kita[#], Jafril Tanjung^{*}, Maldiawati⁺

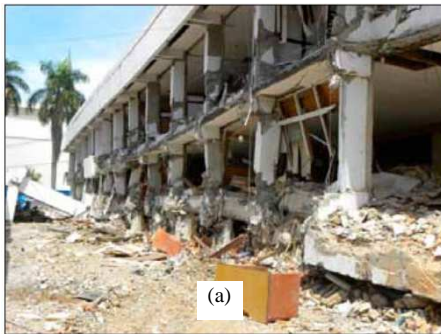
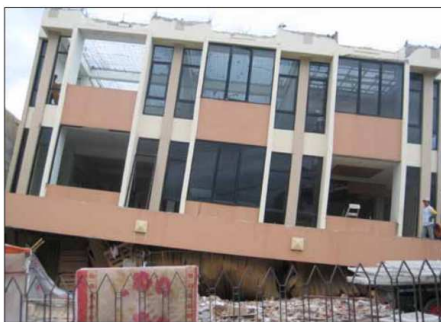
The 7.6 Mw Western Sumatera-Indonesia earthquake had caused significant damage to many reinforced concrete (RC) buildings, including both older and newer buildings. Examples of collapsed multi-story RC buildings in Padang city are shown in Fig. 1. This indicated that enforcement of building codes on buildings built prior to 2009 was lacking in Padang which resulted in deficiencies in design engineering and/or construction practice.

Fig. 1 Example of collapsed buildings; (a) A collapsed 3-story government building; (b) First story failure of a 3-story shop-house [1]

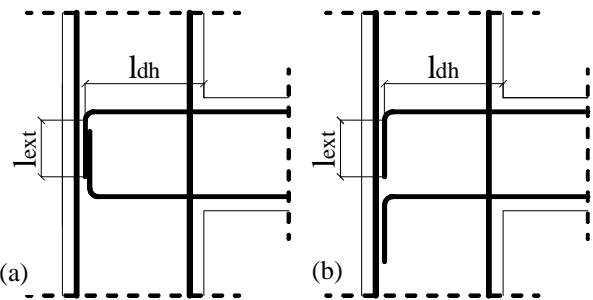
The types of anchorage applied to the investigated buildings are shown in Fig. 22(c). It is widely known that the hooks should be bent into the joint (Fig. 23(a)). However, in two private buildings (5%), both top and bottom beam longitudinal reinforcements were bent downwards (Fig. 23(b)).

Fig. 23 Type of anchorage of beam rebar in exterior beam-column joint; (a) Bent into joint; (b) Bent downwards

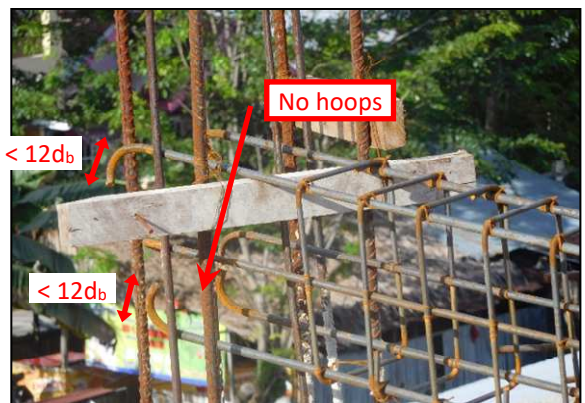
Fig. 24 shows typical deficiencies observed in exterior beam-column joints in which shorter tail extensions (l_{ext}) are applied to anchor beam reinforcement and no hoop is applied.

Fig. 24 Typical deficiencies in exterior beam-column joint
