Monitoring Coastline Changes Using Landsat Application in Batu Mejan Beach

Abstract— Monitoring Coastline changes is a very important task to assess and evaluate the condition of the coastal area. Accurate results of changes in coastline are very useful as a consideration in making decisions for coastal area management and planning for future coastal development. Therefore, coastline changes, both erosion and accretion were examined in this study. Batu Mejan Beach is selected as a study area. It is a tourism destination often visited by foreign and local tourists in North Kuta Beach. Its current condition is very poor because of the erosion that has occurred. The government has tried to build a sea wall for protection, but the structure has failed. Remote sensing is a method that can monitor shoreline changes more efficiently than taking measurements directly into the field. With the remote sensing method, changes in the shoreline at a certain period can be investigated. The remote sensing analysis method is used to extract coastlines from Landsat 7 satellite images in 2002 and Landsat 8 in 2018. Landsat was analyzed using a combination approach of threshold and band ratio methods

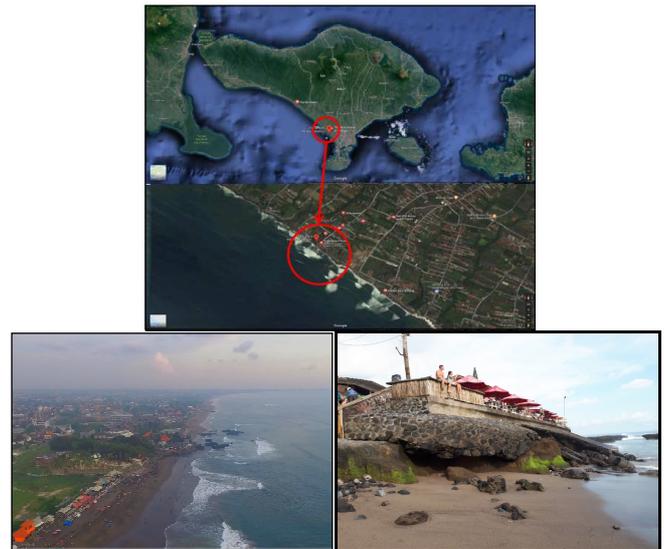
Fig. 1 Location of study.

Figure 1 showed the shoreline when the study was conducted, which was taken using aerial photographs. In some parts of the sea wall has been damaged by the waves. Information from local peoples was obtained that the coastline at the location had declined from the previous year.

The method used in this research is qualitative research by applying survey methods, including interviewing with local people, environmental observations, documentation, field measurements and literature studies. The research was conducted from February 2019 to July 2019 with case studies along Batu Mejan Beach, Canggu Village, Kuta Utara District, Badung Regency, Bali Province can be seen in Figure 1.

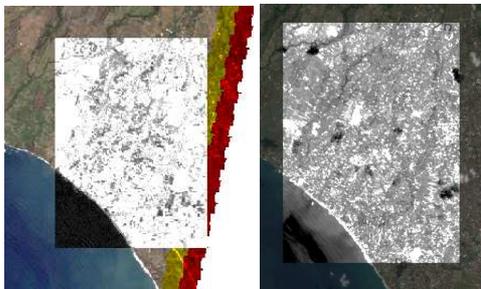
Fig. 2 Image Cutting Result in 2002 and 2018

Image cutting is done to determine the research area because not all areas in the image will be processed. At the stage of the image, cutting is done using the Region of Interest method; in that way, the image is cut to the boundary of a region in the form of a vector. The boundary used in this study is the boundary of the North Kuta District, with coordinates 8.644840°S 115.163254°E. Cutting results can be seen in Figure 2.

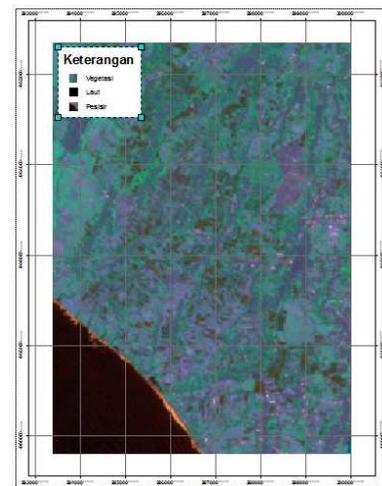
Fig. 3 Composite Band of 2002

The satellite imagery used is Landsat satellite imagery which is multitemporal with a medium spatial resolution of 30x30 meters. The use of medium resolution satellite imagery is suitable for spatial monitoring of coastline dynamics. RGB composite display on Landsat imagery can interpret water, coast (coastline), vegetation, and settlement. The 2002 composite band results can be seen in Figure 3,

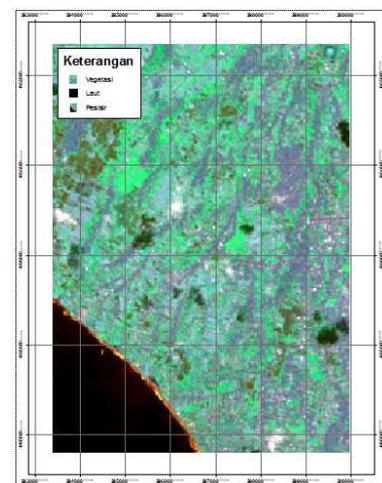
Fig. 4 Composite Band of 2018

and composite band results for Landsat 8 can be seen in Figure 4.

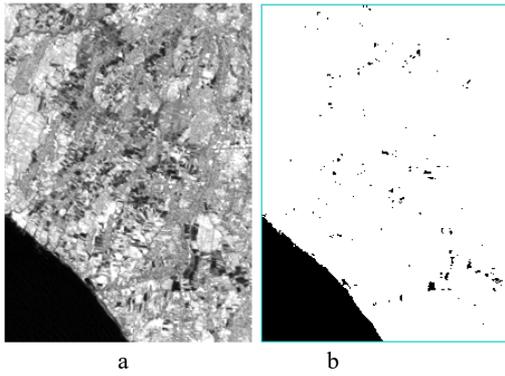
Fig. 5 Landsat 7 image before masking (a) and after masking (b) with threshold suppressors in band 5

The image threshold value of the infrared sensor has an output in the form of a binary image. This approach considers the reflectance value reflected by objects on the earth after receiving waves from satellites. In this approach, the reflectance value of land has an extremely high value, while it has zero value for the sea. The separation of land and sea is converted into binary imagery to facilitate non-guided classification (unsupervised classification). The results of the classification of the threshold value are shown in Figure 5.

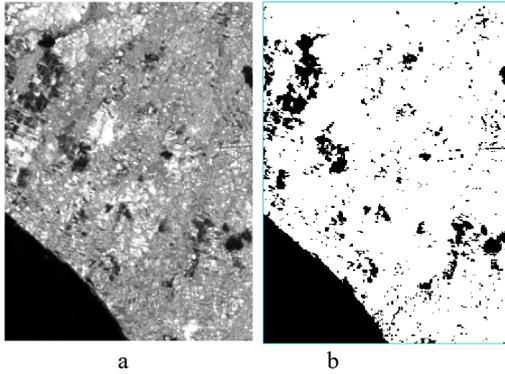
Fig. 6 Landsat 8 image before masking (a) and after masking (b) with threshold suppressors in band 6

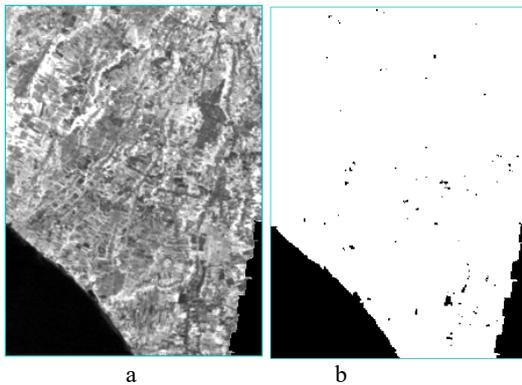
Fig. 7 Landsat 7 image results from the band ratio 4/2 (a) and after masking (b)

The band ratio produces binary images, which are a combination of bands 4, 5, and 2 on Landsat 7 and a combination of bands 5, 6, 3 on Landsat 8. This band ratio approach is to cover the weakness of the threshold that is not classifying vegetation and sand on the beach. The results of the 4/2 band ratio and the binary image of Landsat 7 are shown in Figure 7. Meanwhile, the results of the band ratio of 5/3 and the binary image of Landsat 8 are shown in Figure 8. The results of the 5/2 band ratio and the binary image of Landsat 7 are shown in Figure 9. The band ratio 6/3 and the binary image of Landsat 8 are shown in Figure 10.

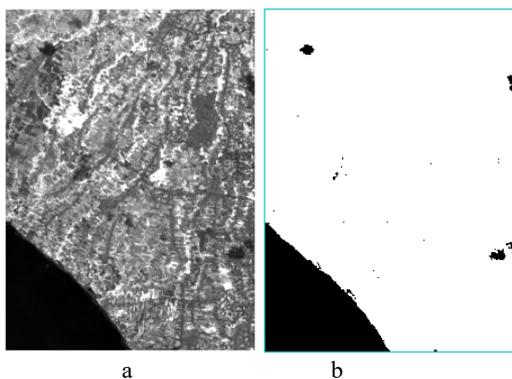
Fig. 8 Landsat 8 image results from the band ratio 5/3 (a) and after masking (b)

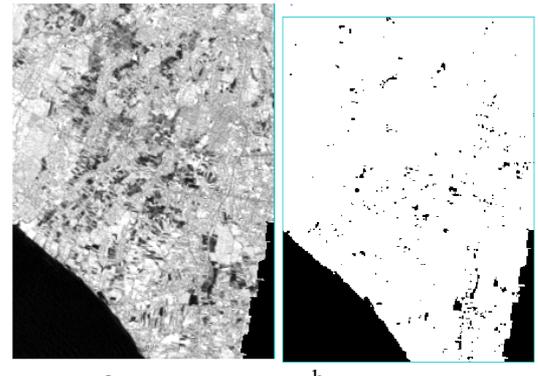
Fig. 9 Landsat 7 image results from band ratio 5/2 (a) and after masking (b)

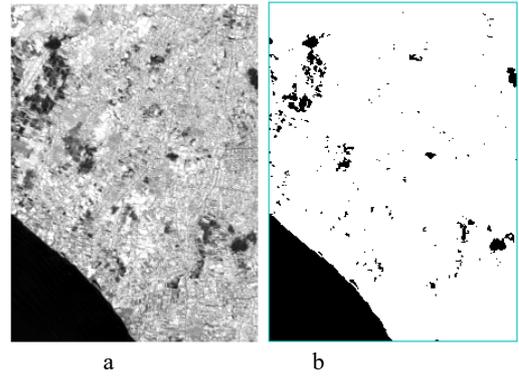
Fig. 10 Landsat 8 image results from band ratio 6/3 (a) and after masking (b)

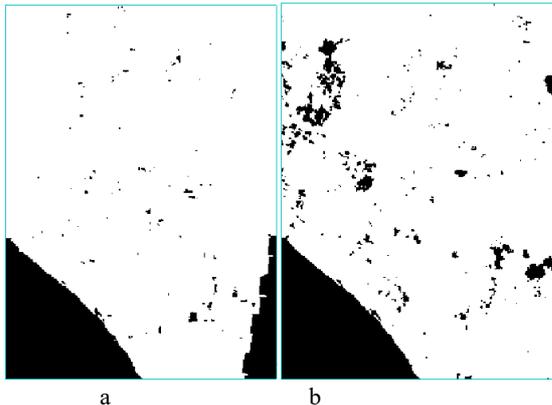
Fig. 11 The combination of 2002 (a) and the combination of 2018 (b)

The result of each Landsat image threshold and band ratio approaches, then combine with the multiplication operation to get the binary image of the two approaches. The shoreline delineation results from Landsat imagery are more accurate by combining the threshold and band ratio approaches. The merging of the threshold with the band ratio is done by multiplication. The combined results of the band ratio with the threshold can be seen in Figure 11.

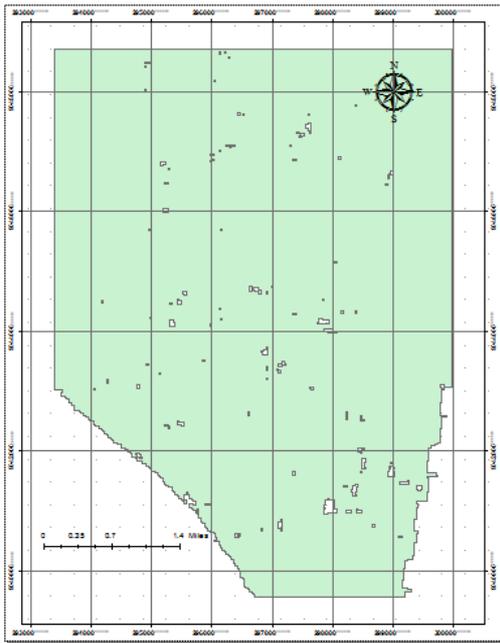
Fig. 12 Vector of coastline polygon in 2002

The steps taken after all the correction processes to the separation of land and sea boundaries from the Landsat satellite imagery for the North Kuta area are the digitization process. In this process, the corrected image in vector form is used as a drawing base for the shoreline to be analyzed. The results of the vector that have been corrected can be seen in Figure 12 for 2002 and Figure 13 for 2018.

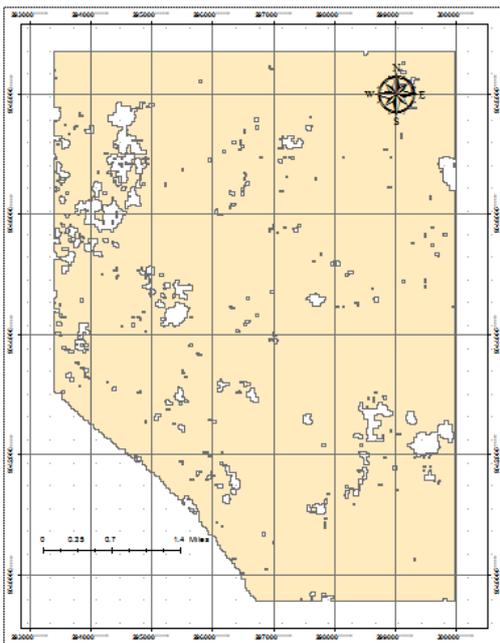
Fig. 13 Vector of coastline polygon in 2018

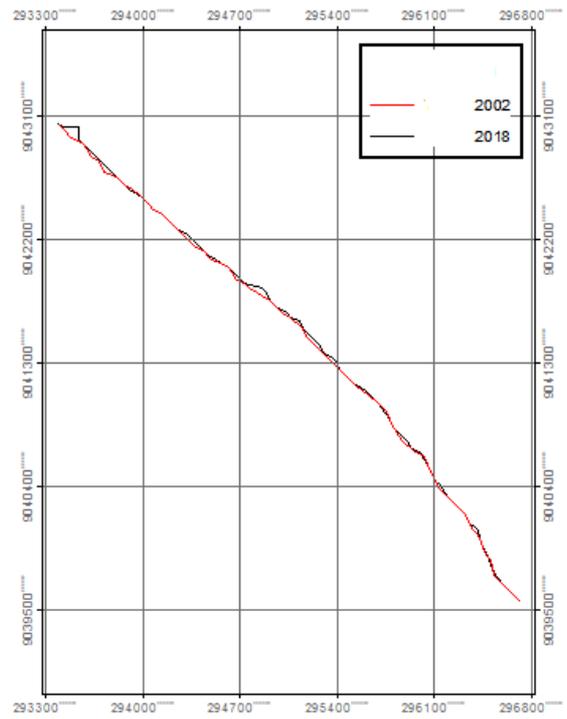
Fig. 14 The coastline results in 2002 and 2018 from the digitization process

The vector of the results already shows the difference, which one island and the other is the ocean. The vector results that have been obtained are used as a basis for digitizing the coastline, which is continued using the ArcGIS program. The results of digitization can be seen in Figure 14.

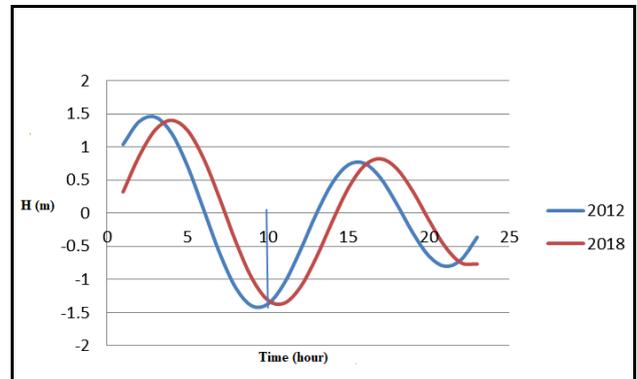
Fig. 15 Tidal pattern charts for 2002 and 2018

The coastline that has been obtained from the digitization results must be corrected first by using the tidal data of the image area under review. Tidal data can be seen in Figure 15. The data obtained from [5] in the form of a slope distribution map on the island of Bali can be seen in Figure 16.

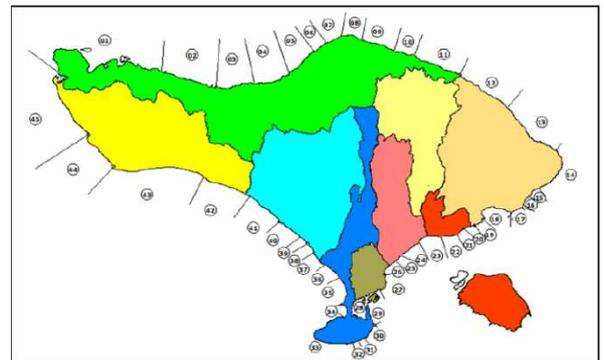
Fig. 16 Map of the Distribution of Slopes on the Island of Bali (Source: BWS-BP, 2015)

In Figure 16 data, it is explained that the North Kuta sub-district is on sections 35 and 36, and the slope data covering the section can be seen in Table 1.

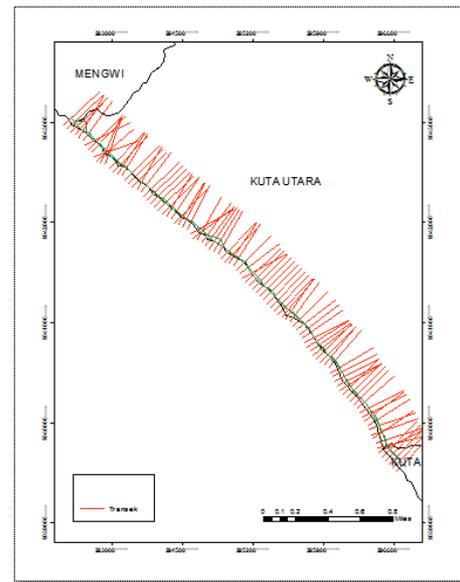
Fig. 17 Transect calculation of the distance between the North Kuta coastline

The distance between the coastlines that have been overlapped is calculated using a manual transect that is made following the contours of the coastline. Transects made have an interval of 50 meters and a length of 500 meters. The distance between transects is made 50 meters to cover almost all changes that occur, while the length of 500 meters is made to anticipate the coastline that does not cut transects so that the distance calculation between coastlines can be done. The shoreline transect calculation is seen in Figure 17.

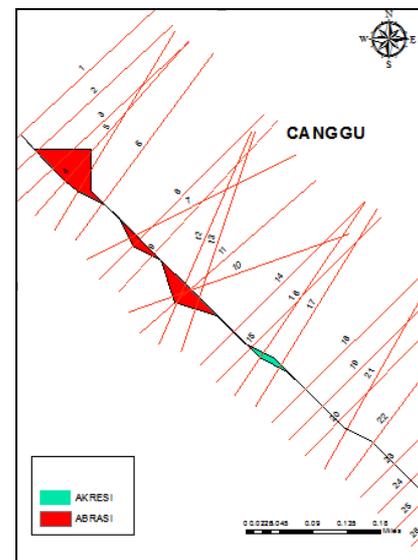
Fig. 18 Overlapping the Batu Mejan coastline

The coastline resulting in the Landsat image extraction changed from 2002 to 2018. Researchers visually made the identification of changes, with the shoreline of each year being overlapped. Identification of shoreline changes is carried out along the Batu Mejan beach, which is in transect 1 to transect 22. Identification of changes in the coastline of Batu Mejan can be seen in Figure 18.

The changes in coastline's pattern changes in Batu Mejan Beach experiences dominant erosion. Erosion that occurs on average is quite high. The highest erosion occurred on the 4th transect with 82.84 meters. Accretion only occurs in transects 15, 16 and 17, with the highest accretion on transect 16 of 13.52 meters. The average change in coastline at Pantai Batu Mejan is 17.34 meters. Changes in the coastline at Batu Mejan Beach are shown by the graph in Figure 19. The rate of change in the coastline at Pantai Batu Mejan is dominated by erosion. Rate of change in the coastline at Batu Mejan Beach showed abrasion of 0.11-5.14

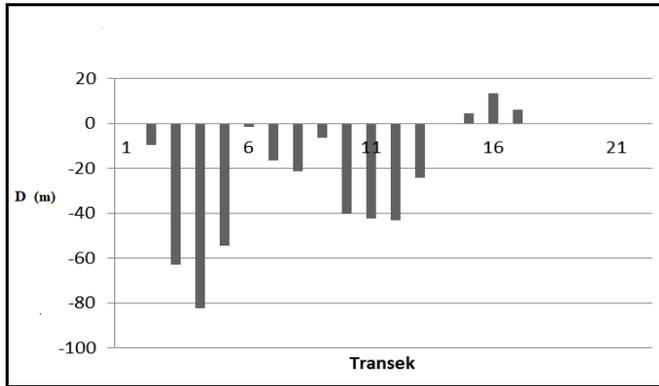
Fig. 19 A graph of the coastline changes of each transect in Batu Mejan Beach

m/year and accretion of 0.29-0.84 m/year. The highest erosion rate occurred in the 4th transect of 5.14 m/yr, and the average rate of change in the coastline at Batu Mejan Beach was 1.08 m/yr.

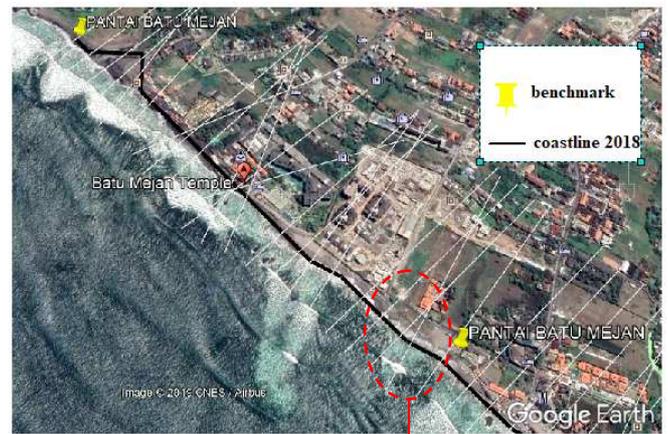
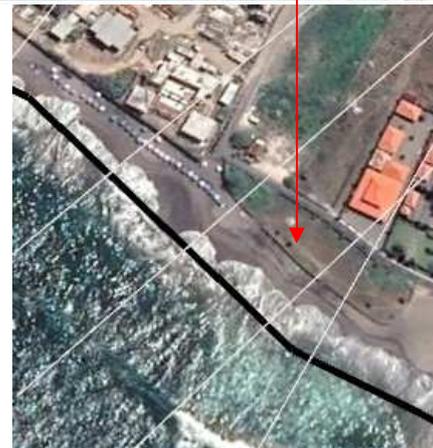
Fig. 21 Results of a coastline overlay with Google Earth in 2018

The coastline vector resulting from Landsat image delineation must be validated with valid data to determine the method's accuracy. The data used for validation can be from various sources, such as from data taken directly in the field or other data from other sources such as Google Earth data. This study uses visual validation by overlaying the coastline that was created with maps obtained from Google Earth. The overlay result matches the coastline that has been created with a map from Google Earth [19] can be seen in Figure 20 and Figure 21.

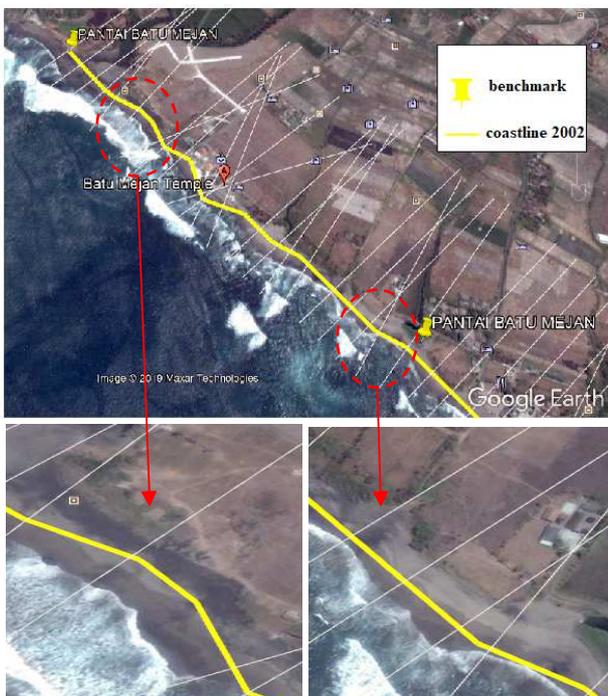
Fig. 20 Results of a coastline overlay with Google Earth in 2002
