Evaluation of the Pre-Cracked RC Beams Repaired with Sealant Injection Method

Abstract—This paper presents an experimental study on the pre-cracked reinforced concrete beams repaired with sealant injection method. The purpose of this study is to evaluate the flexural and shear capacity of the repaired beams. Due to this purpose, totally six beams consisting of three beams for flexural and three beams for shear investigation were prepared and tested. Two beams identified as control specimens were tested until failure, while the others were pre loaded until 50% and 90% of yield load (in case of flexural) and ultimate load (in the case of shear). The cracks in pre-cracked beams were injected with sealant injection method at selected locations. Then, after 24 hours the repaired beams were again tested until failure. Test results showed that stiffness of the beams after pre load is slightly increased compare to that initial specimen. In addition, the flexural and shear capacity of the repaired beams slightly increase compare to that control specimens.

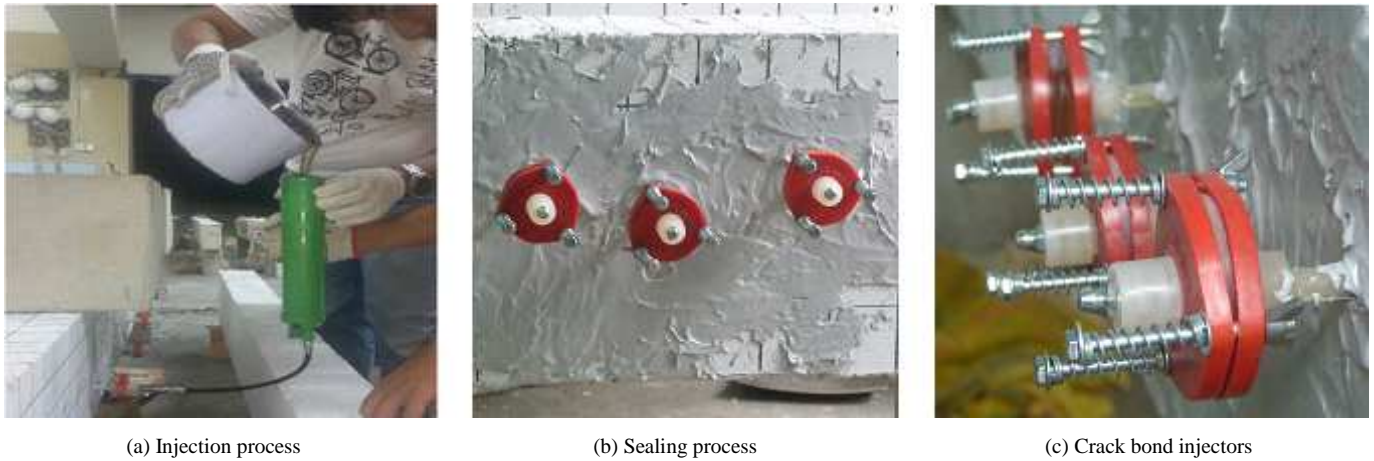
Fig. 2 The process of sealant injection method

The cracks were repaired by epoxy resin with low and constant injection pressure named sealant injection method [9]. The system of sealant injection method used was consisted of crack bond injector (consists of injecting nozzle, push plates, plug, spring, nut, and bolt), AOI grout No. 1 and No. 2 being the injection materials (epoxy resin base), and EPO BOND EP-3 being the sealing material (epoxy resin base). The procedure for repairing a crack includes: surface preparation, seal crack at surfaces, installation of the crack bond injector, injecting AOI grout, and remove the sealing material. The photographs showing the process are shown in Fig. 2.

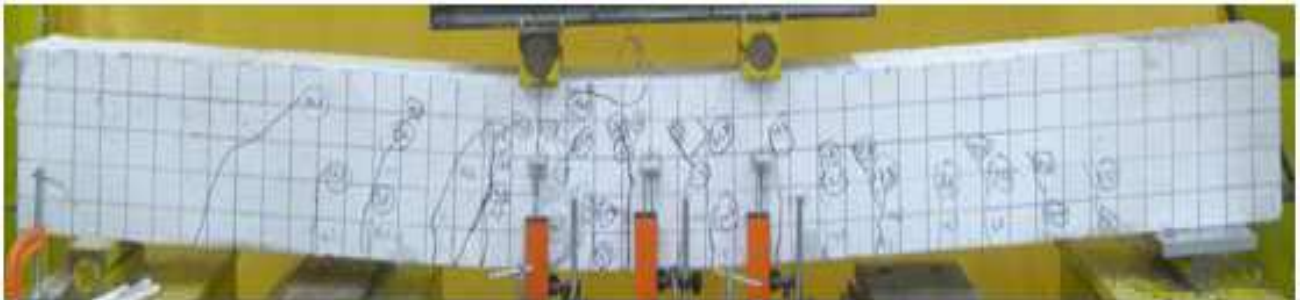
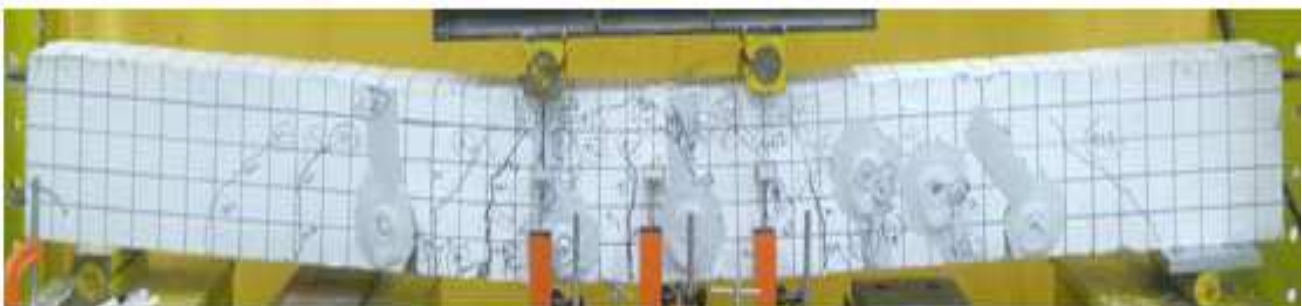
(a) BF-C (control beam)

(b) BF-01 (pre-cracked 50% of yield load)

(c) BF-01R (repaired)

(d) BF-02 (pre-cracked 90% of yield load)

(e) BF-02R (repaired)

Fig. 3 Crack patterns of control, pre-cracked and repaired beams (BF type)

The maximum flexural capacity of control specimen of BF type (BF-C) observed from the test was 26 kN with the yield load of 20.6 kN. The BF-C beam failed in flexural failure modes as indicated by crushing of concrete on the top surface of the compression zone. The next two beams of BF type (BF-01 and BF-02) were loaded until the pre-cracked loads of 10.3 kN and 18.5 kN, respectively. The cracks were then repaired by epoxy resin with low and constant injection pressure. Then, after 24 hours the repaired beams were again tested until failure. Typical crack patterns of BF type are shown in Fig. 3.

It was observed from the crack pattern of the beams that the injected cracks perform higher cracking load capacity compare to the initial crack load in pre-cracked beams. It is also observed that a number of cracks in repaired beams are higher than the control beams. It was also noticeable that the injection of epoxy resin was evenly effective in restoring the strength of the damaged beam.

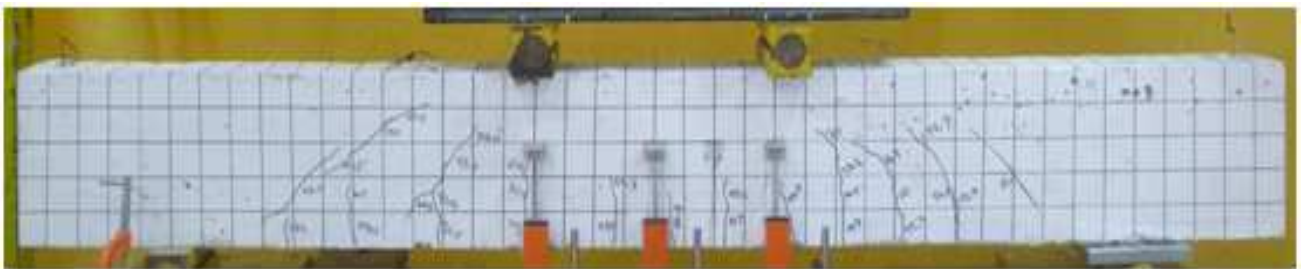
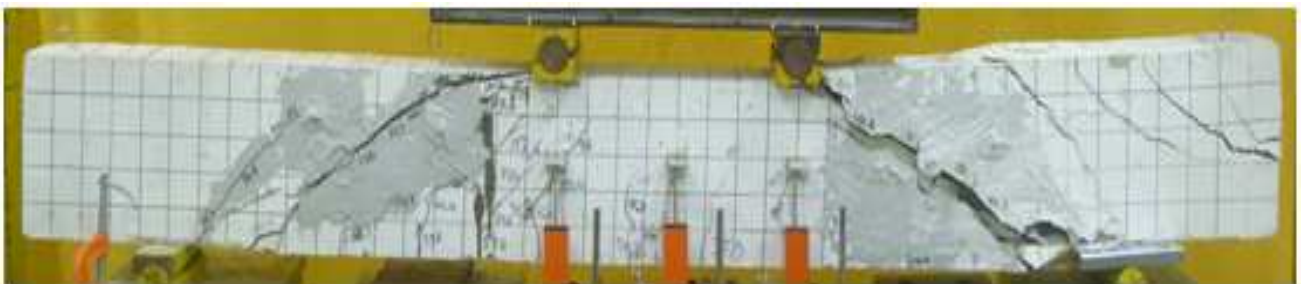
(a) BS-C (control beam)

(b) BS-01 (pre-cracked 50% of ultimate load)

(c) BS-01R (repaired)

(d) BS-02 (pre-cracked 90% of ultimate load)

(e) BS-02R (repaired)

Fig. 4 Crack patterns of control, pre-cracked and repaired beams (BS type)

The same procedure was applied to BS type beams. The ultimate load of BS-C beam obtained from the test was 81.7 kN. The BS-C beam failed in shear with dominant shear cracks developed in the shear span zone. Then, BS-01 and BS-02 were loaded until the pre-cracked loads of 40.9 kN and 73.5 kN, respectively. Fig. 4 shows typical crack patterns of BS type. It is also confirmed from Fig. 4 that the diagonal shear cracks significantly develop in the shear span zone for all of the BS types.

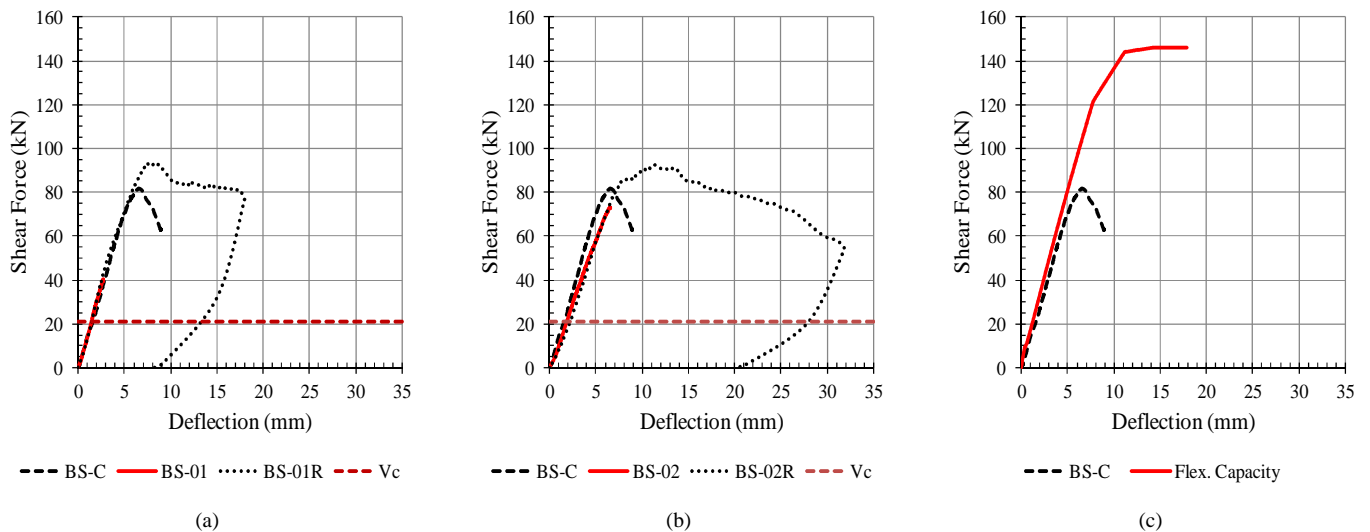
Fig. 6 shows BS type beams that were tested to evaluate the shear capacity of the repaired beams. The red dash line

plotted in Fig. 6(a) and (b) specify the shear capacity provided by concrete, V_c . This value (V_c) was calculated using equation adopted from SNI 2847:2013 code [13]. It is shown from Fig. 6 that pre-crack loads for BS type are higher than V_c to make sure that the diagonal cracks previously developed before the repairing process as expected in this study

The pre-cracked beam (BS-01) was preloaded until 50% of the ultimate load and illustrates with a red line in Fig. 6(a). Then, the pre-cracked beam was injected with sealant injection method at locations of the shear crack. The repaired beams were again tested until shear failure. It is shown from Fig. 6(a) that the capacity of the BS-01R beam after pre-cracked and repaired is slightly increased compare to that control specimen (BS-C).

Fig. 6(b) shows BS-02 beam that was pre-loaded until 90% of the ultimate load. It is also shown from Fig. 6(b) that the capacity of the BS-02R is slightly increased compare to that control specimen.

Fig. 6 Experimental and analytical load-deflection curves of BS type
