Common Structural Details and Deficiencies in Indonesian RC Buildings: Preliminary Report on Field Investigation in Padang City, West Sumatra

Syafri Wardi^{#+}, Yasushi Sanada[#], Michihiro Kita[#], Jafril Tanjung^{*}, Maldiawati⁺

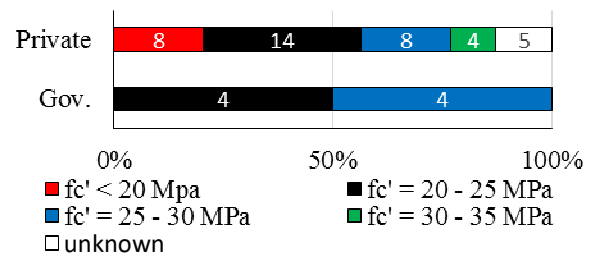
Fig. 6 Investigation results in concrete compressive strength

1) *Concrete Material:* For RC buildings in the high seismic risk area, the Indonesian concrete design code [3] has provisioned the minimum concrete compressive strength (f_c') to be 20 MPa. However, eight private buildings (20%) did not meet this requirement, as shown in Fig. 6. These buildings applied concrete with the standard of K-225 (cubical compressive strength of 225 kg/cm²) which corresponded to cylindrical compressive strength (f_c') of 18 MPa.

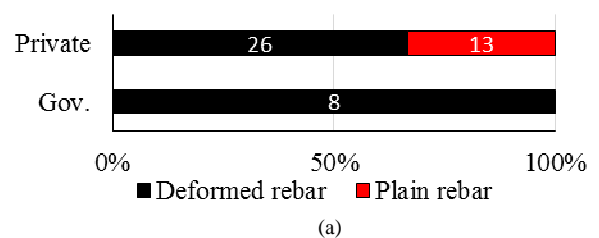
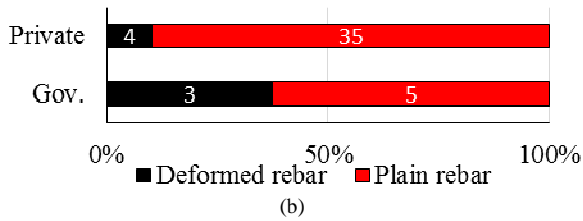
Fig. 7 Investigation results on types of rebar used as reinforcement; (a) Longitudinal reinforcement; (b) Transverse reinforcement

2) *Rebar Material:* The Indonesian concrete design code [3] has regulated that deformed bar should be used as reinforcement. The plain bar is allowed to use only for spiral reinforcement. However, thirteen private buildings (33%) applied plain rebar for longitudinal reinforcement, as shown in Fig. 7(a). Furthermore, thirty five private buildings (90%) and five government buildings (62%) applied plain rebar for transverse reinforcement, as shown in Fig. 7(b). Plain rebar is not recommended especially for flexural reinforcement because it has very low bonding without mechanical interlocking with concrete.

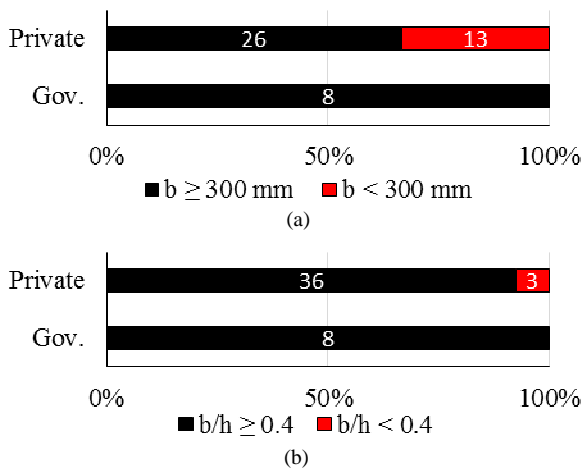
Fig. 8 Investigation results on cross-sectional dimensions of the column; (a) Minimum cross-sectional dimension; (b) Ratio of cross-sectional dimensions

1) *Dimensions of Column:* Column with too small dimensions can lead to “weak column-strong beam” mechanism which may cause story collapse of buildings. The Indonesian code [3] regulates that the shortest cross-sectional dimensions of column shall be not less than 300 mm and the ratio of the shortest cross-sectional dimension to perpendicular dimension shall be not less than 0.4. However, thirteen private buildings (33%) did not meet the requirement for the minimum cross-sectional dimensions and three private buildings (8%) did not meet the requirement for the ratio of cross-sectional dimensions, as shown in Fig. 8(a) and 8(b).

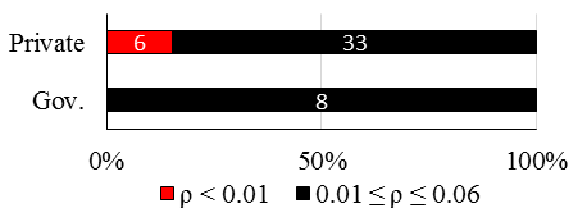
Fig. 9 Investigation results on the ratio of flexural reinforcement in column

2) *Longitudinal Reinforcement in Column:* According to the Indonesian code [3], the volumetric ratio of longitudinal reinforcement (ρ) shall be not less than 0.01 and shall not exceed 0.06. However, six private buildings (15%) did not meet the requirement of the minimum reinforcement ratio, as shown in Fig. 9. Columns with longitudinal reinforcement less than the minimum have the potential of yielding resulting from creep deformations of concrete, which may lead to premature flexural failure of the columns.

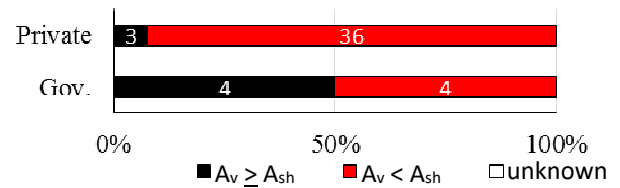
Fig. 10 Investigation results in the area of transverse reinforcement in column

The symbols in Equations can be referred to Nomenclature. Fig. 10 shows that thirty six private buildings (92%) and four government buildings (50%) did not meet the requirement for the area of transverse reinforcement. Many of them lacked inner hoops (cross-ties).

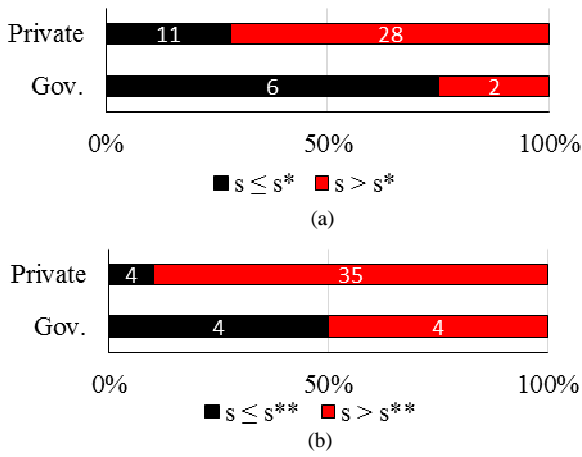
Fig. 12 Investigation results on the spacing of transverse reinforcement in the column; (a) Hinge region; (b) Non-hinge region

Fig. 11 describes the requirements for the maximum spacing of transverse reinforcement in accordance with the Indonesian code [3]. The investigation results in Fig. 12(a) show that twenty eight private buildings (72%) and two government buildings (25%) did not meet the requirement for the spacing of transverse reinforcement in the hinge region. Moreover, thirty five private buildings (90%) and four government buildings (50%) did not meet the requirement for the spacing of transverse reinforcement in the non-hinge region, as shown in Fig. 12(b).

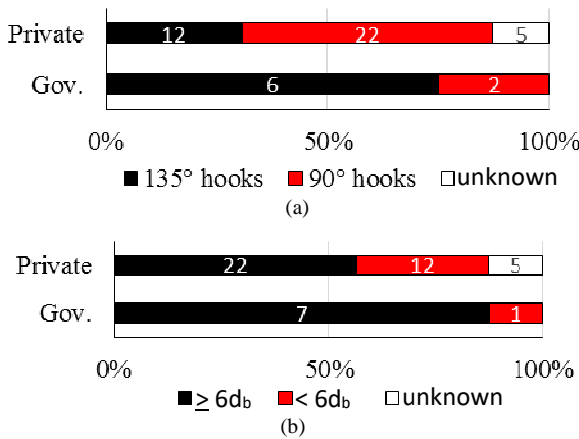
Fig. 13 Investigation results on details of seismic hooks of column stirrups; (a) Angle of hooks; (b) Length of hooks

The Indonesian code [3] also stipulates application of seismic hooks with 135° or more and the length not less than $6d_b$ (transverse bar) to column stirrups. However, in real construction, twenty two private buildings (56%) and two government buildings (25%) applied 90° hooks, as shown in Fig. 13(a). Moreover, twelve private buildings (31%) and one government building (12%) applied hooks of column hoops with the length less than $6d_b$, as shown in Fig. 13(b).

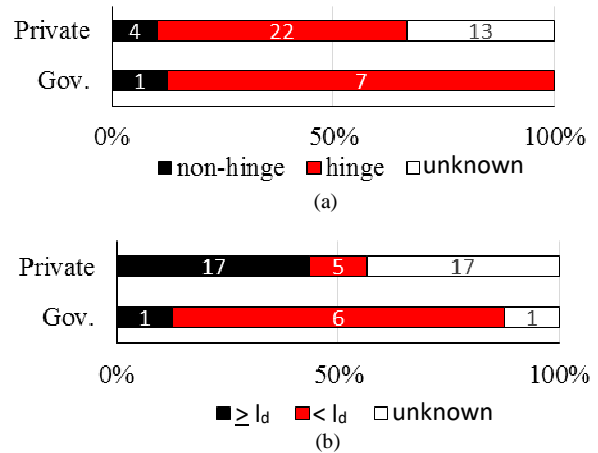
Fig. 14 Investigation results on lap splice in the column; (a) Location of splice; (b) Length of splice

4) *Lap Splice in Column*: The Indonesian code [3] regulates that no lap splice shall be used within the joint or within a distance of twice member depth from the face of joint (hinge area). However, twenty two private buildings (56%) and seven government buildings (87%) applied lap splices in this potential hinge area, as shown in Fig. 14(a). Moreover, the lap splice of column shall be designed as a tension splice; thus the length shall not be less than:

Fig. 14(b) shows that five private buildings (13%) and six government buildings (75%) did not meet the requirement for the length of lap splice. In many buildings, the length of

lap splice was conventionally defined as $40d_b$ (longitudinal bar) which tends to give smaller length than Equation (3) or (4).

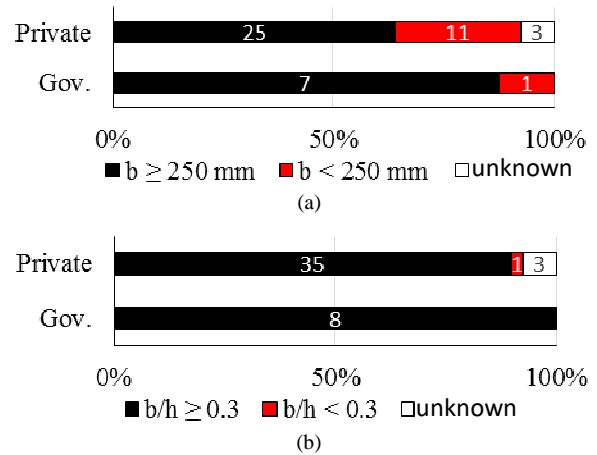
Fig. 15 Investigation results on cross-sectional dimensions of the beam; (a) Minimum width; (b) Ratio of width to depth

1) *Dimensions of Beam*: The Indonesian code [3] has provisioned that width of the beam shall be ≥ 250 mm, and the ratio of width to depth shall be ≥ 0.3 . However, eleven private buildings (28%) and one government building (12%) did not meet the requirement for the minimum width, as shown in Fig. 15(a). Moreover, one private building (3%) did not meet the requirement for the ratio of width to depth, as shown in Fig. 15(b).

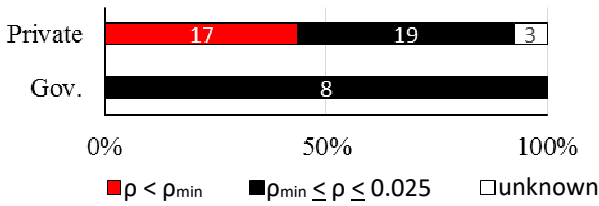
Fig. 16 Investigation results on the ratio of longitudinal reinforcement in the beam

2) *Longitudinal Reinforcement in Beam*: According to the Indonesian code [3], the minimum area of tensile or compressive reinforcement in beam shall not be less than the maximum value obtained by Eq. 5 and Eq. 6, and the reinforcement ratio shall not exceed 0.025. However, seventeen private buildings (43%) did not meet the requirement of the minimum reinforcement ratio, as shown in Fig. 16.

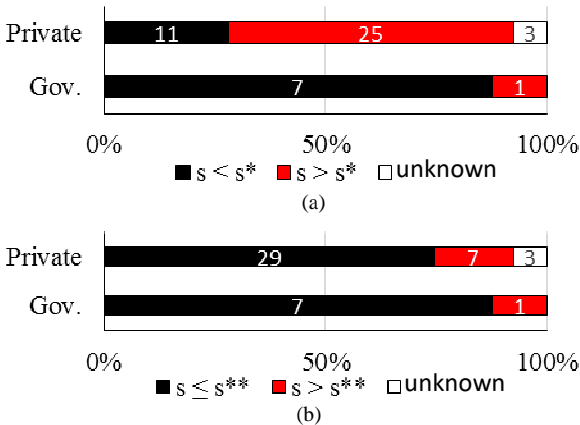
Fig. 18 Investigation results on the spacing of transverse reinforcement in the beam

3) *Transverse Reinforcement in Beam:* Requirements for the maximum spacing of transverse reinforcement in the beam in the Indonesian code [3] are described in Fig. 17. The investigation results in Fig. 18(a) shows that twenty five private buildings (64%) and one government building (12%) did not meet the requirement for the spacing of transverse reinforcement in the hinge region. Furthermore, seven private buildings (18%) and one government building (12%) did not meet the requirement for the spacing of transverse reinforcement in the non-hinge region, as shown in Fig. 18(b).

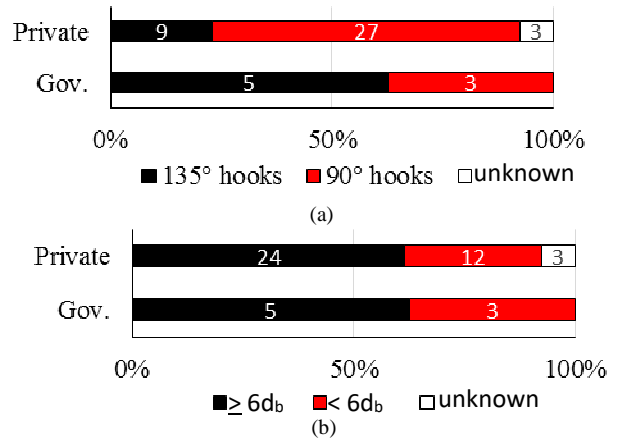
Fig. 19 Investigation results on details of seismic hooks of beam stirrups

Seismic hooks with 135° or more and the length not less than $6d_b$ (transverse bar) shall be applied to beam hoops. However, in real construction, twenty seven private buildings (69%) and three government buildings (37%) applied 90° hooks, as shown in Fig. 19(a). Moreover, twelve private buildings (31%) and three government buildings (37%) had the length of hooks of stirrups less than $6d_b$, as shown in Fig. 19(b).

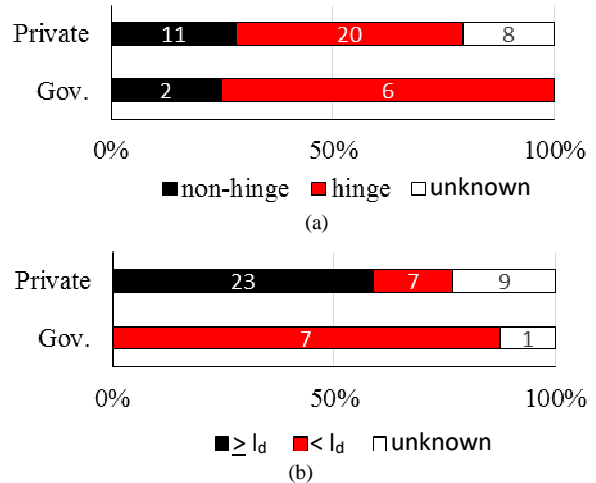
Fig. 20 Investigation results on lap splice in the beam; (a) Location of splice; (b) Length of splice

4) *Lap Splice in Beam:* The provisions for lap splices in the beam are similar to those on the column as explained in Section III.B.4. The investigation results in Fig. 20(a) shows that twenty private buildings (51%) and six government buildings (75%) applied lap splices in the hinge region. Fig. 20(b) shows that seven private buildings (18%) and seven government buildings (87%) had lap splices with lengths less than the required length (l_d). In many buildings, the length of lap splice in the beam was conventionally defined as $40d_b$ (longitudinal bar) which tends to give smaller lengths than required by the latest code [3].

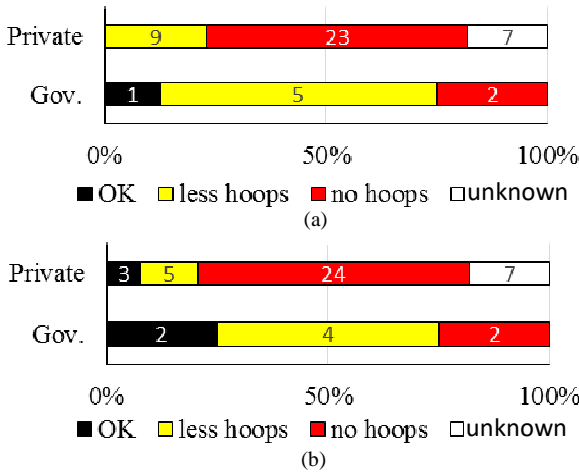
Fig. 21 Investigation results on hoops in beam-column joint; (a) Exterior joint; (b) Interior joint

Fig. 21(a) shows the investigation result of hoop details in the exterior beam-column joints. Most of the investigated buildings did not satisfy the requirements for hoops in the exterior joint. For private buildings, twenty three cases (59%) contained no hoops in the exterior joints, while nine

cases (23%) contained hoops less than the requirements. For government buildings, five cases (62%) contained hoops less than the requirements, while two buildings (25%) contained no hoops.

Fig. 21(b) shows the investigation result of hoop details in the interior beam-column joints. Only three private buildings (8%) and two government buildings (25%) satisfied the requirements for hoops inside the interior joint. Other buildings contained no hoops or insufficient hoops to the interior joints. In construction practice, hoops in the exterior and interior joint were likely not to be applied or reduced to eliminate difficulties posed by rebar congestion.

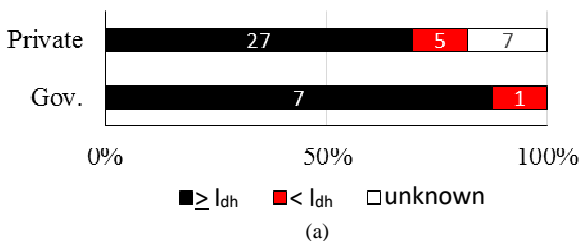
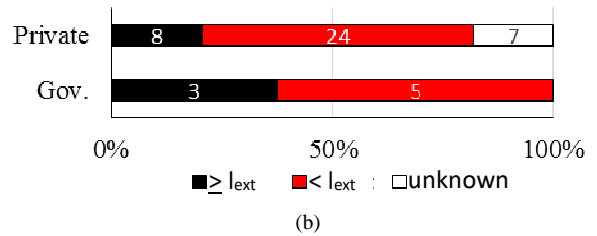
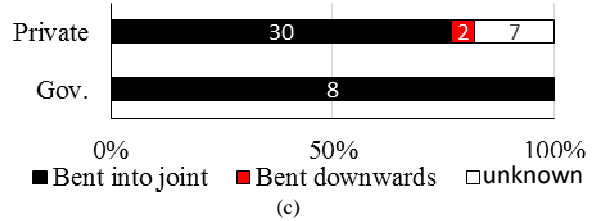
Fig. 22 Investigation results on hoops in beam-column joint; (a) Length of anchorage; (b) Length of tail extension; (c) Type of anchorage

The end of rebar should be bent with a 90° hook, and the length of tail extension (l_{ext}) shall not be less than $12d_b$ (longitudinal bar). Many of the investigated buildings satisfied the requirement for the length of anchorage (l_{dh}), as shown in Fig. 22(a). However, many did not satisfy the requirement for the length of tail extension (l_{ext}). Fig. 22(b) shows that twenty four private buildings (61%) and five government buildings (62%) had the length of tail extension (l_{ext}) less than $12d_b$.

The types of anchorage applied to the investigated buildings are shown in Fig. 22(c). It is widely known that the hooks should be bent into the joint (Fig. 23(a)). However, in two private buildings (5%), both top and bottom beam longitudinal reinforcements were bent downwards (Fig. 23(b)).
